检 验 报 告

TEST REPORT

产 品 名 称 Ceramic Suspension Insulator

检 验 类 别 Prototype Tests

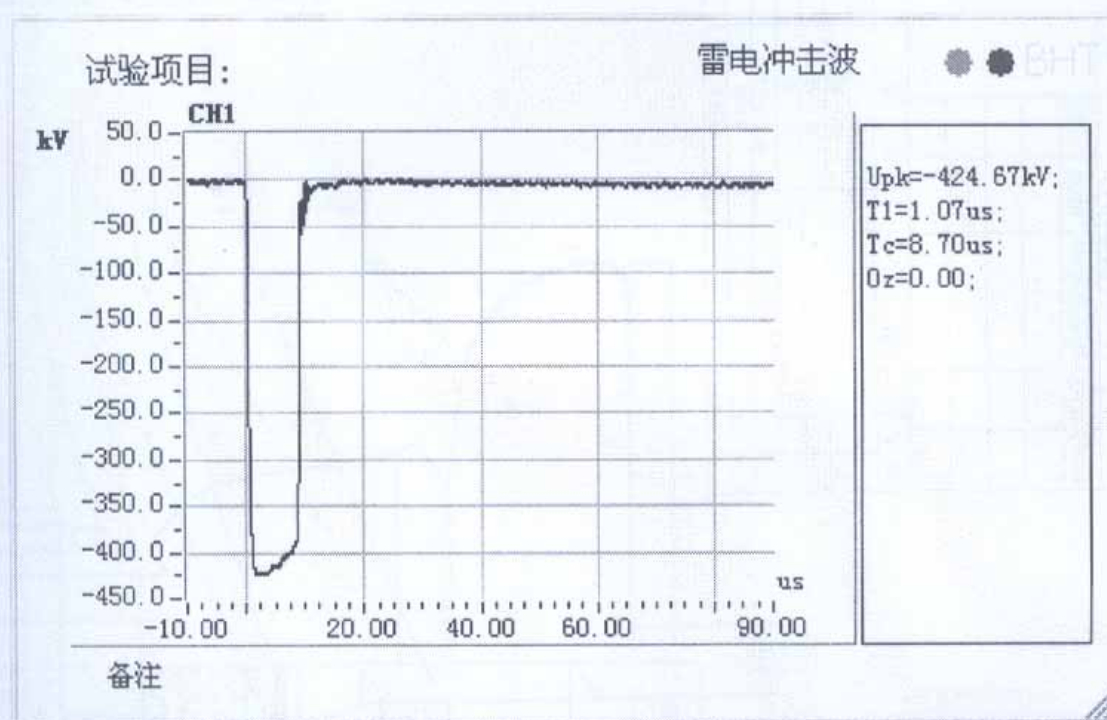
Fig 4: waveform of negative polarity lightning impulse voltage (flashover)

12.2 Negative polarity

Specimen No.	Times applied	U_{50} kV	Corrected value kV
13~17 (short string)	30	414.8	434.3
Specifications	/	/	≥ 364.0 , (1.040×350)
